# Failure Analysis of Rear Axle Shaft Dump Truck Capacity 7.5 Ton

<sup>1</sup>Angwar Mukhojin, <sup>2\*</sup>Sri Nugroho, <sup>3</sup>Ismoyo Haryanto

<sup>1,2,3</sup>Mechanical Engineering Department, Diponegoro University, Semarang, Indonesia

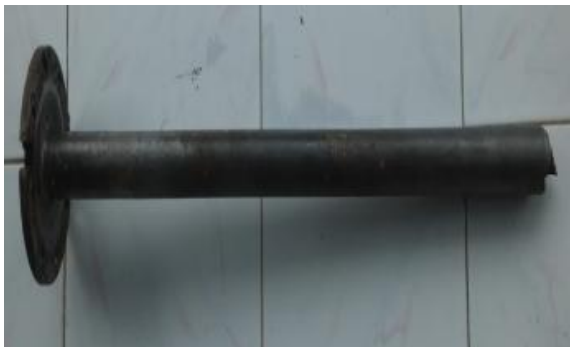
Figure 1: Rear axle shaft

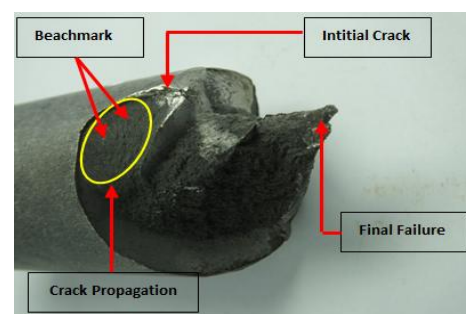
On macroscopic examination, there is an initial crack, crack propagation (beachmark), and final failure. The initial crack is located at the edge and is characterized by a shinier surface and there are fine lines that show the beginning of the crack. The second part is crack propagation characterized by a rougher circular line (beachmark) with a darker color. This shows the rapid propagation of cracks from the edge that is experiencing case hardening to the core area. At the end it forms an angle of about  $45^\circ$  with a very rough and dark fault surface, indicating the final fracture shown in figure 2. The beachmark is visible on the edge area to the core area and a fault groove is obtained in the direction of the beachmark until the final fracture [24, 25]. The final shape of the fault is filamentous and has an angle of  $45^\circ$  [2].

Figure 2: Macroscopic examination

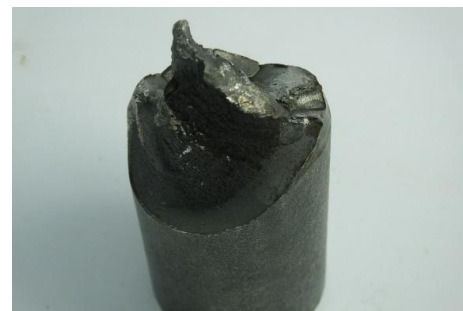
Crack propagation occurs at the edges because it has a higher hardness value as a result of the case hardening process, this results in brittle properties in the axle shaft, while the core part has a lower hardness value, but has tenacious properties so that the fault surface tends to be rough, filamentous and forms a  $45^\circ$  angle. So macroscopically the fracture that occurs is a fatigue fracture shown in figure 3. In other studies, the fault surface forms a  $45^\circ$  angle and is dark in color, and tends to be filamentous [2].

Figure 3: The fault surface is filamentous and forms a  $45^\circ$

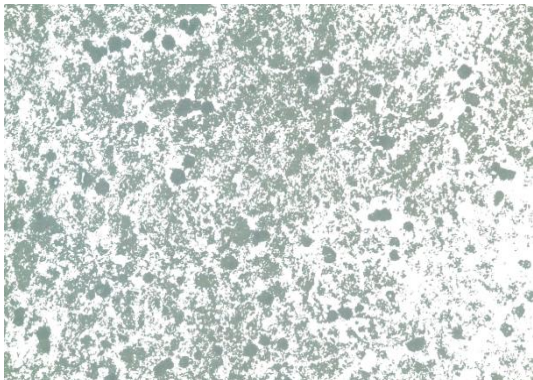
After macroscopic observations are made, microscopic observation steps are done by using metallurgical microscopes (microstructure tests) and SEM. As the results of microstructure testing there are phase differences formed in the axle shaft, in the core area there is a ferrite-pearlite phase and at the edges shows the martensite phase. The shows the presence of case hardening that is carried out on the axle shaft, the thickness of the hardening case reaches 9 mm and exceeds the specified standard of 2-3 mm shown in figures 4 and 5. Other studies have shown that in the core there is a ferrite-pearlite phase and at the edges, dominated by the martensite phase [2,4,5,11,31].

Figure 4: Microstructure test results on the core area

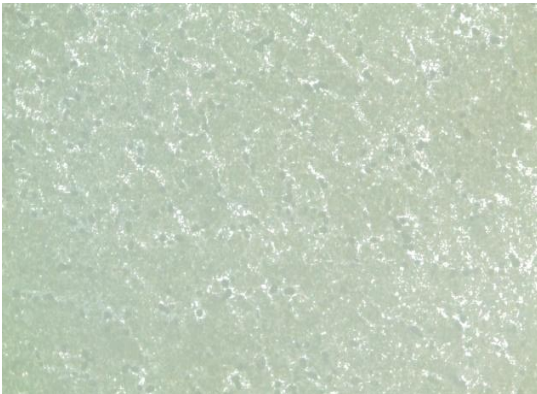
Figure 5: Microstructure test results on the edge

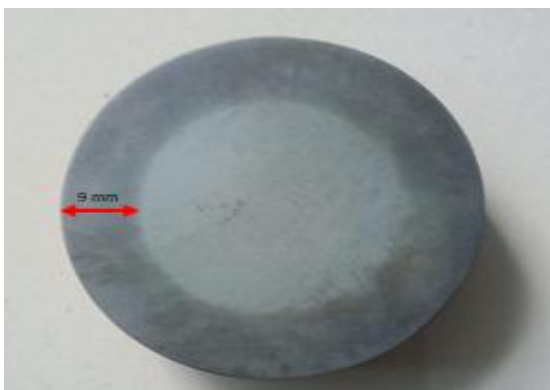
Figure 6: Case hardening thickness

- 2) The results of microstructure testing show the ferrite-pearlite phase at the core and the martensite phase at the edges, this is by the criteria of the material undergoing case hardening. The thickness of the hardening case is obtained by 9 mm, higher than the specified standard limit (2-3mm).

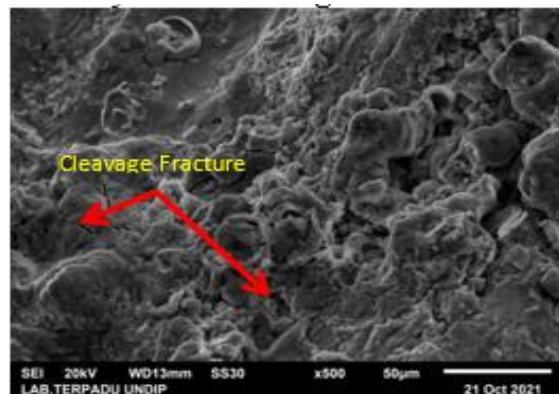
The results of the SEM test show that the edge has a cleavage fracture with a smooth surface and a brightness color, when viewed from the mechanism of the fracture cleavage fracture showing brittle properties, this is in line with the results of macroscopic observations that show an initial crack in the edge area, in terms of these results leading to case hardening carried out on the rear axle shaft to increase the hardness value and result in brittle properties in the edge area. In other studies Cleavage, Fracture, and river type were also seen at the edges which showed brittle properties in the area [2,9,30]. While the core area shows the presence of striation, that is smooth lines that are circular throughout the cross-sectional area of the rear axle shaft, a further dimple is found near the striation. The results of observations on the core area are in line with macroscopic examinations that show the propagation of cracks (beachmark) and final fracture in the core area. Another study found dimples in the core area, accompanied by fatigue striation [2,9,30]. The fault angle that makes up 45° indicates tenacity in the core region. These results can be seen in figure 7 and 8.

Figure 7: SEM test results edge parts

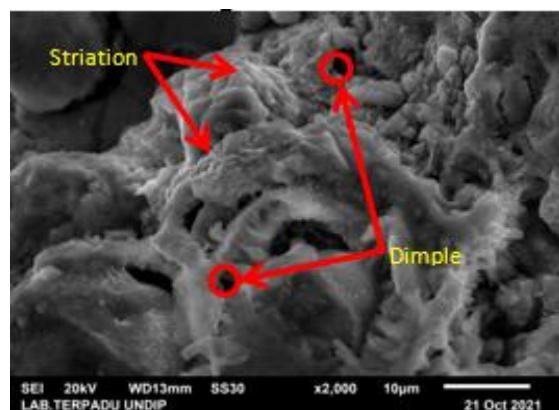
Figure 8: SEM test results core parts

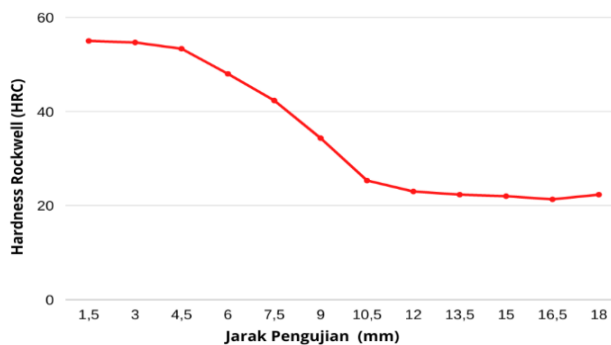
Figure 9: Hardness test result graph (HRC)

From this data, a hardness value of 45.7 HRC was obtained in areas that received case hardening (peripheral areas). Meanwhile, areas that do not get case hardening (core areas) have a hardness value of 22.5 HRC. The hardness value obtained above the specified standard is 36-42 HRC in areas that get case hardening and in areas that do not get case hardening 13 HRC. The core hardness value is obtained at a distance of 10.5 mm from the edge area, indicating that the layer thickness exceeds the specified standard limit (2-3mm). The improper heat treatment process may be the cause of the increase in hardness value above the specified standard and layer thickness. In previous studies, the hardness values obtained along the rear axle were uneven [2-3], and the phase formed in the edge area (martensite) and the core area (ferrite-pearlite) [5-8]. Layer thickness is affected by temperature and holding time in the case hardening process [32-33].
