Damage Analysis of Cylinder Head Components on 3406C Industrial Diesel Engines using Fishbone Diagrams

Abstract - Damage to diesel engine cylinder head components can cause crucial problems. This study describes the methods used to identify the causes of diesel engine cylinder head damage based on visual observations and interviews with technicians. The results of this study will provide a better understanding of the root causes that cause damage to the diesel engine cylinder head components used at PT. Pertamina Drilling Services Indonesia. This study provides an overview of effective repairs and maintenance to overcome these problems with the aim of increasing engine performance and extending component life.

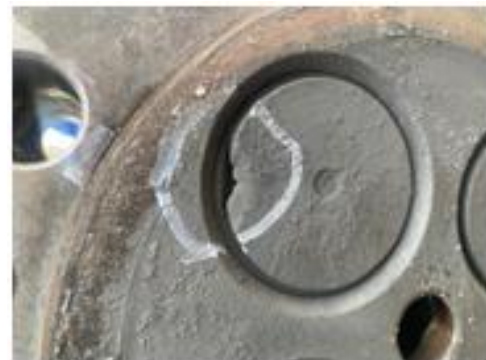
The most common valve failure is bending and cracking due to contact with the piston head. This happens because of the accumulation of soot in the combustion chamber so that the valve heads and piston heads meet or touch. The piston head has a higher hardness than the valve, using AISI 4140 material with a hardness level of 50-60 HRC. Therefore, if the valve is in contact with the piston head for a long time, it may cause damage to the valve. Contact between the valves and the piston head usually occurs due to engine synchronization errors, such as damage to the timing belt or improper belt installation. Bent valves can cause more serious engine problems, including damage to the cylinder head, pistons, and cylinder bores. One of the causes of bent valves is a worn or damaged timing belt (Nationwide Bearing Co. 2017). The timing belt is important in setting the exact time to open and close the intake and exhaust valves, which is also known as the valve timing diagram. This diagram is made based on the movement of the piston in the cylinder. The following is the condition of a broken valve shown in Figure 2.

Figure 2: Valve damage (perforated and broken)

Cracks can occur due to the collision of two different types of material. Materials that have a lower level of hardness will lose and become chipped. This happens because of the impact loading of the valve head with the piston head.

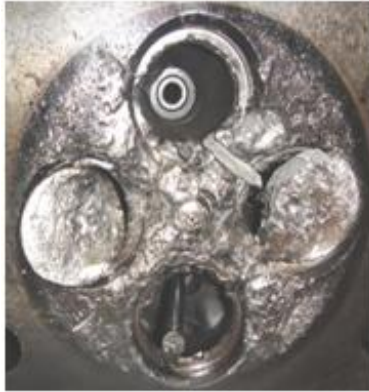
A common type of valve failure is burnt valve which is caused by a leak of combustion gas between the valve and valve seat. The hot gas burns the edge of the valve if the leak is not repaired. Austenitic stainless steel 304, which is commonly used in valve manufacture, has an operating temperature limit of around 870 degrees Celsius. The gas leak temperature in a Caterpillar 3406 diesel engine is 1300-2200

degrees Fahrenheit, and if the valves are not properly sealed then the hot combustion gases can cause burning of the valve edges. This type of failure usually affects the exhaust valve and can damage the intake valve. (Southside, 2012). Figure 3 shows an example of damage to a burnt valve.

Figure 3: Burnt Valve

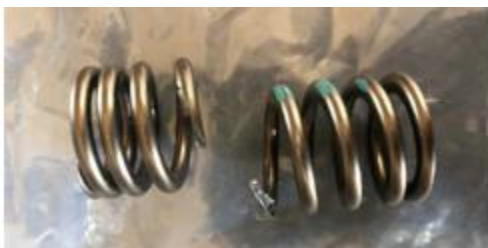
The damage that occurs to the cylinder head spring valve component is a broken spring (fracture). This can happen because of an error in installing the spring when installing the spring component on the valve stem, causing the pressure experienced by the spring to be uneven and making the spring work imperfect. The following Figure 4 shows a broken spring valve.

Figure 4: Spring valve damage

The Caterpillar 3406 diesel engine has a service life before overhaul on the valve spring components of 12,000 working hours. However, often the spring is damaged, such as a broken spring, because the load exceeds the safety factor of the spring. Overload or overload can be caused by an error in installing the spring on the valve stem which results in uneven pressure and imperfect spring work. This reduces spring life to less than 12,000 working hours and adversely affects engine performance and incomplete combustion.

To solve this problem, an urgent repair is required when the engine suffers from a decrease in performance. This involves replacing springs during minor overhauls, to prevent a domino effect on other components that are still functioning normally and avoid major overhauls. In the drilling industry, machines work continuously so that a small disturbance can affect the entire drilling process. As a precautionary measure, there is usually a spare machine available which is used when there is a problem with the main machine.

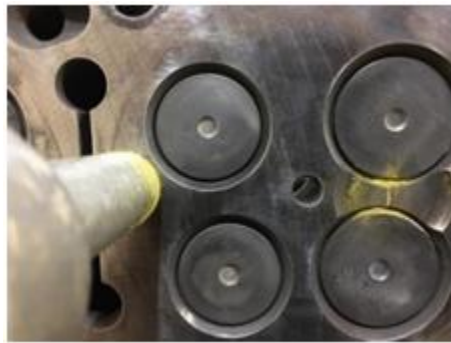
Figure 5: Damage to the cylinder head block

Under normal conditions, diesel engines operate at temperatures of 104-111°C, where the value of the tensile strength of the material used does not change significantly (Costa, 2011). However, if the engine operates at abnormal temperatures, especially overheated temperatures, high pressure will be experienced on the cylinder head, cylinder liners and engine block. If the temperature is not controlled while operating, this can cause damage to the engine components, especially the cylinder block. This causes a decrease in the tensile strength of the material when the engine combustion chamber temperature increases, which is a factor affecting material fatigue. The tensile strength of materials, such as gray cast iron and other types of cast iron tends to decrease in the temperature range of 20-150°C (Costa, 2011).

As a result of a decrease in the tensile strength of the material, the material will experience fatigue more quickly and have an impact on damage. This is accelerated by the material environmental conditions which do exist at too high temperature conditions, causing excess pressure on these components. The damage that occurs to the cylinder block components is in the form of cracks in the cylinder block (Niaga Kita, 2019). Overheating of the engine can occur due to an error in the cooling system in a diesel engine. If the coolant ducts are not externally treated to keep them clean without obstruction in airflow along with not retaining coolant allowing internal blockage and tube blockage, overheating will result. If the engine continues to work under conditions of severe and excessive overheating it will cause cracks in the cylinder head block. This will result in engine performance and damage to other components. A cracked engine block can cause a variety of problems. Ultimately, because the circulation system that cools the engine is relatively fragile, a cracked engine block will cause coolant to leak out of the area where it is needed and overheat the engine. If not corrected, this will lead to engine failure which may result in the engine stopping operation. Cracked engine blocks can result in low

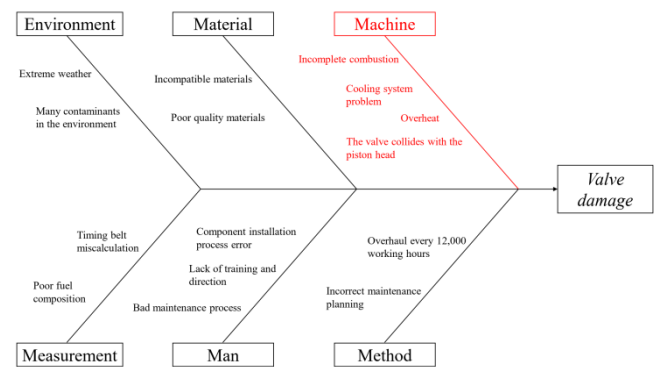
Figure 6: Fishbone diagram analysis for valve damage

In the results of the analysis using fishbone diagrams, it was found that there were 6 (six) factors that caused damage to the valve components in the cylinder head which consisted of method, machine, man, measurement, environment and material. In engine factors, incomplete combustion and problems with the cooling system can cause damage to the cylinder head valve components. Incomplete combustion results in excess soot buildup on the valves, while a faulty cooling system can cause engine temperatures to rise excessively. Both can affect valve performance and service life.

The damage that occurs to the valve is in the form of a puncture on the valve so that it makes the valve perforated. This can happen because of the collision between the valve and the piston head. Under normal conditions this does not happen. The collision occurs because there is an accumulation of soot left over from combustion in the valve head so that the distance or difference between the valve and the piston head which should have a distance and does not intersect ends up colliding, as a result the valve loses in terms of material strength and a puncture occurs in the valve.

To overcome the engine factors, good care and maintenance is very important. This includes routine monitoring of engine performance, cleaning and maintenance of the combustion system, inspection of the cooling system, and replacement of damaged or worn components. By maintaining optimal combustion and a good cooling system, the risk of damage to valve components can be reduced and engine performance can be maintained properly.

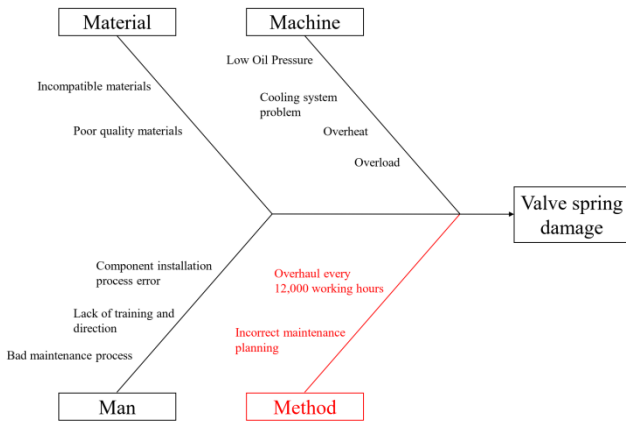
Figure 7: Fishbone diagram analysis for spring valve damage

The method factor is one of four factors that can cause damage to the valve spring in the cylinder head. This factor involves aspects related to the methods or procedures used in the care, maintenance, installation and operation of spring valves. Overhaul every 12,000 working hours which is the age limit of the spring valve. Spring valve has a recommended operational life limit, it is usually recommended to overhaul or replace at certain intervals, such as every 12,000 working hours. If the overhaul is not carried out according to the specified age limit, then there is a risk of damage to the spring valve due to wear and tear and material fatigue that is not repaired or replaced on time. Apart from having reached the wrong maintenance planning limit, improper maintenance planning can cause a lack of maintenance or excessive maintenance of the spring valve. If maintenance planning does not take into account the need for appropriate maintenance, such as cleaning, lubricating, or replacing damaged components, then the spring valve can wear or damage more quickly.

In maintaining performance and preventing damage to spring valves, it is important to follow proper maintenance methods, maintain the overhaul schedule according to the

recommended age limits, carry out appropriate maintenance plans, and provide adequate training and guidance to operators or technicians who are responsible for maintenance spring valve.

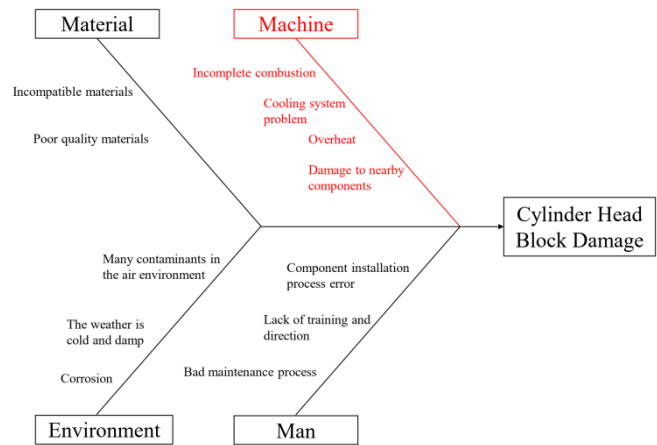
Figure 8: Fishbone diagram analysis for cylinder head block damage

Engine factor is one of the four main causes of damage to cylinder head components. A cooling system that is not functioning properly or problems with engine cooling components can cause an overheated condition in the engine. Overheating occurs when the engine temperature exceeds normal limits which can result in damage to the cylinder head. Excessive heat can affect the mechanical properties of the material, including changes in dimensions and a decrease in strength. This can cause deformation or cracking of the cylinder head, reducing the performance and service life of the component.

Incomplete combustion, the combustion process in the engine may experience disturbances, such as imperfections in the mixing of air and fuel or the presence of obstacles in the combustion process. Incomplete combustion can generate excess heat and increase pressure in the cylinder head. This can cause damage to components, including cracking or deformation of the cylinder head due to overpressure.

It is important to pay attention to and address these factors in maintaining engine performance and preventing damage to cylinder head components. This includes good maintenance, including monitoring of engine temperature and pressure, maintenance of an effective cooling system, meeting the need for adequate lubrication, and ensuring the workload of the machine does not exceed the set limits. Paying attention
