Failure Analysis of Pinion Gear Dump Truck

¹Miftah Yanottama, ^{2*}Sri Nugroho, ³Sulardjaka

^{1,2,3}Mechanical Engineering Department, Diponegoro University, Semarang, Indonesia

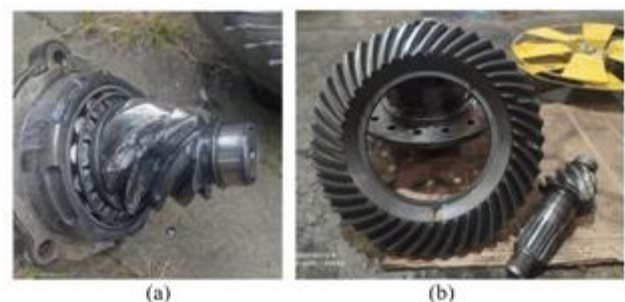
Figure 1: (a) pinion gear (b) ring gear dan pinion gear

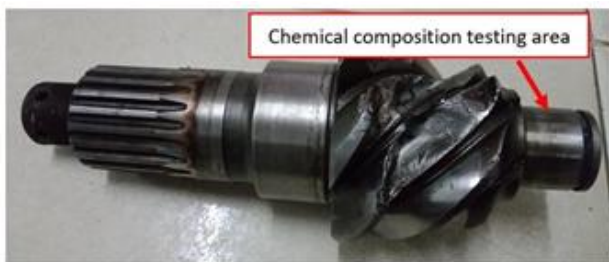
Figure 2: Pinion gear area for chemical composition test

Table 1 shows the results of the chemical composition test of pinion gear components. Based on the above test data, the chemical composition of the components does not conform to AISI 8620 standard materials. The Mn element has a percentage of 0.949% which is higher than the AISI 8620 standard with a range of 0.70 – 0.90%. Ni and Mo elements have lower levels than material standards, while Cr elements are higher than AISI 8620 materials with a range of 0.40 – 0.60% which can result in increased hardenability, corrosion resistance, and also steel abrasion resistance because the addition of chromium is a carbide-forming element [6].

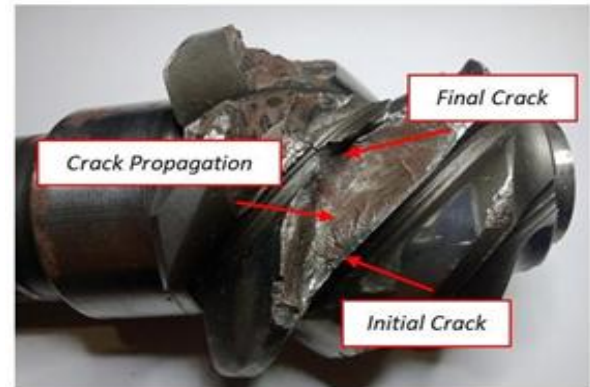
Figure 3: Macro photo of the failed pinion gear surface

Figure 3 indicates the surface of the pinion gear that has failed. It can be seen that the initial crack is on the surface of the tooth in contact with the ring gear, then the crack propagates to the inside of the pinion gear (crack propagation) and there is a final fracture or final crack on the opposite part of the pinion gear gear.

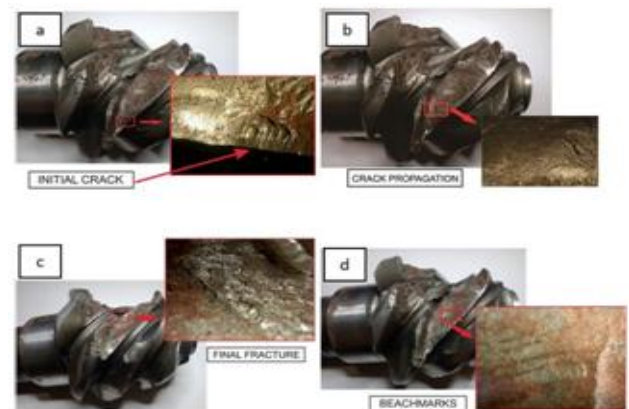
Figure 4: Stereomicroscope on fault area (a) initial crack; (b) crack propagation; (c) final crack; and (d) beachmarks

Figure 4 (a) shows the initial crack (crack initiation) in the pinion gear due to repeated tension-compression blocking. Then the direction of the crack spreads into the pinion gear. Crack propagation has a smoother surface compared to crack propagation. Figure 4 (b) shows crack propagation which then the direction of the crack spreads even more inward, namely to the part opposite to the initial crack. Figure 4(c) shows a final fracture characterized by the presence of coarse grains and the absence of macro-visible beachmarks, so it is very clear that this part is the final fracture area. Figure 4 (d) indicates the

presence of beachmarks on the fracture surface of the pinion gear. Beachmarks indicate a tired fracture. Beachmarks profiles are the result of fluctuations in the load exerted on objects [7].

Judging from the results of macro observations using a stereomicroscope, it appears that fractures that occur on the surface of pinion gear teeth can be categorized as tired fractures. Fatigue fracture occurs through three stages, namely the initial crack stage (crack initiation), the crack propagation stage (crack propagation), and the static fracture stage (final crack). After the tired crack propagates far enough, then the working load will only be supported by the remaining cross-section that has not been cracked and finally the component will break (final failure stage) [8].

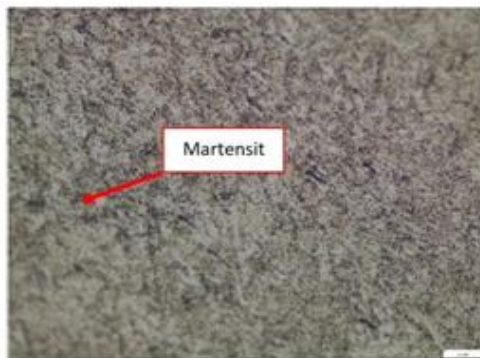
Figure 5: Micro Test Results of pinion gear tooth surface parts

From the results of microscopic testing, the surface of the pinion gear teeth shows an even distribution of martensite, which can be seen in Figure 5. While the core of the pinion gear has a martensite phase that is less common than the surface area, it can be seen in Figure 6. These results, when viewed visually, appear to be visible black spots on each sample. The resulting martensite shape difference is the influence of heat treatment on components. The effect of holding time also affects the thickness of the case hardening process layer. Looking at the core of the pinion gear teeth that have entered the martensitic phase [9-10].

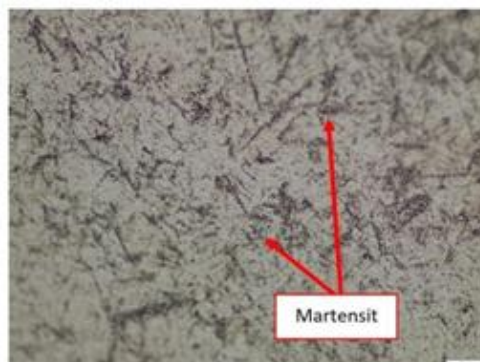
Figure 6: Micro Test Results of pinion gear tooth core parts

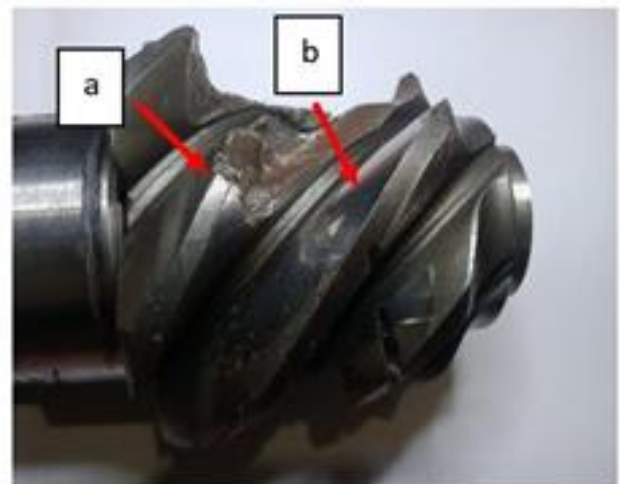
Figure 7: Hardness testing area

This hardness test is used to determine the hardness distribution of pinion gear teeth that are near failure (Figure 7 point a) and that are far from failure (Figure 7 point b). This test uses an indent of 5 points; the indent is carried out on the surface area up to the inside of the pinion gear with a loading of 100 kgf and an indentation time of 10 seconds. The division of the indented area can be seen in Figure 7.

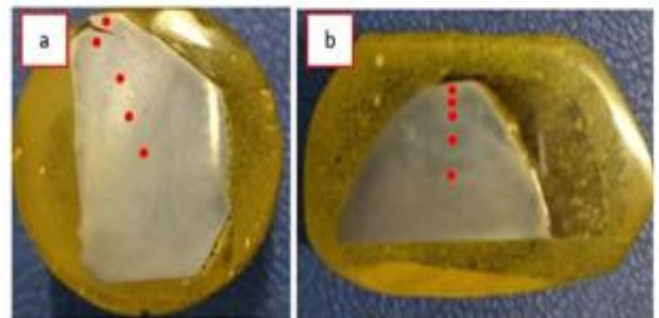
Figure 8: (a) Indentation of hardness test area close to a fracture (b) indent hardness test area far from the fracture

From Table 2 the hardness value of pinion gear teeth in areas close to faults has a higher surface hardness of 776 HV compared to areas far from faults of 753 HV. From this, this component has increased hardness in areas that experience faults when compared to those that are far from faults.

From the specimens, both also show where the middle of the pinion gear has a lower hardness than the surface. Where the more to the middle area the value of violence is visible. It can be known that the pinion gear gets surface hardening treatment.

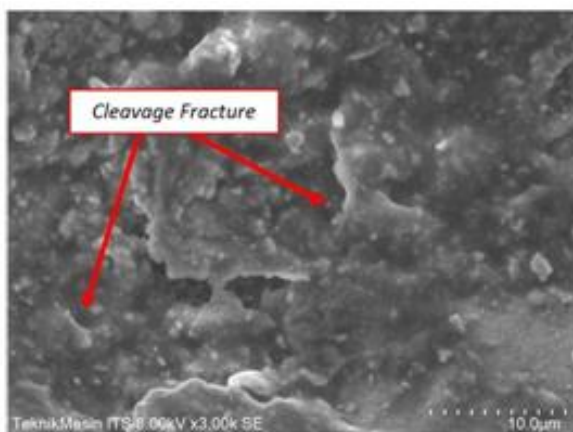
Figure 9: SEM Test Results in the initial crack area

The results of the SEM test in the initial crack area (Figure 9) with a magnification of 3000x can be observed that the fault surface has grains that tend to be smooth and form hollows, this indicates the characteristics of brittle fractures with the show of cleavage fracture [11]. The area has a high hardness resulting in brittle fractures on the surface of the pinion gear teeth.

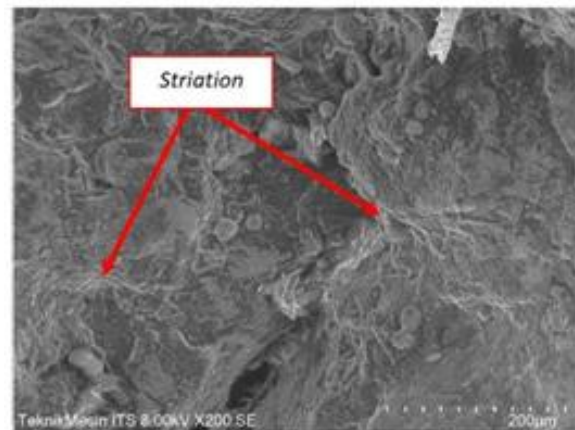
Figure 10: SEM Test Results in the crack propagation area

In the SEM test results, the crack propagation area (Figure 10) with a magnification of 200 x has a rougher structure than the initial crack. It can be seen from the test results that there is striation which indicates the propagation of cracks in the section [12]. Macroscopic testing also showed beachmarks on the fault surface.
