# Maintenance and Repair of Ship Propeller Shafts

This research aims to examine the process of maintenance and repair of the propeller shaft on the KMP Kirana I, which is one of the passenger and cargo ships operating in the Indonesian maritime area, carried out at PT Janata Marina Indah.

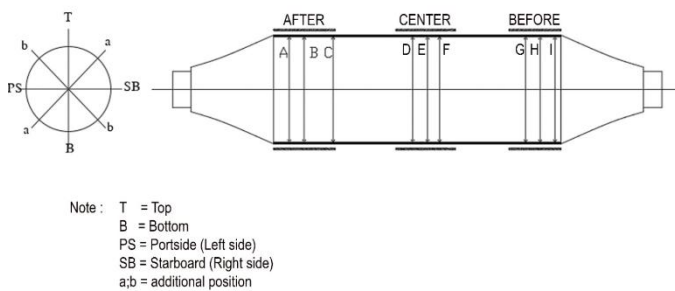
From the results of checking the clearance and damage, results will be obtained in the form of a record containing the clearance of the ship being checked. The ship whose clearance will be checked is KMP Kirana I which uses seawater lubrication shafts. Figure 1 shows the model of the propeller shaft on the KMP Kirana I ship.

Figure 1: Propeller shaft model

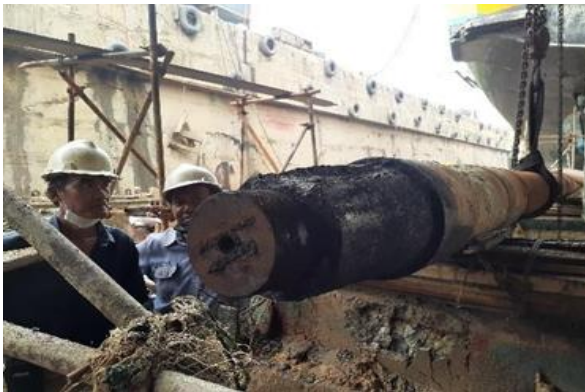
When the shaft was lifted, many wear points were found on the shaft. Wear indicates the start of defects in the shaft [3]. Wear is the result of friction generated between the shaft and other rubbing machine elements. Wear is usually caused by shaft misalignment and improper maintenance [4]. At the time of observation, the damage that occurred was 15mm of shaft loss with a layer of rust around it. This layer of rust occurs due to the corrosive working environment of the shaft in the form of seawater.

The shaft that was evaluated during practical work had damage in the form of loss of parts and shaft. This loss occurs due to friction between the shaft and the bearing in that part. Apart from erosion, rusting occurs on this part which is caused by long-term contact with seawater. The condition of the damaged shaft is shown in Figure 2.

Figure 2: Shaft loss in the after section

To overcome these two problems, technicians repaired them using composites. This composite is a 2-part composite for metal repair and resurfacing based on solventless epoxy resin reinforced with silicon steel alloy.

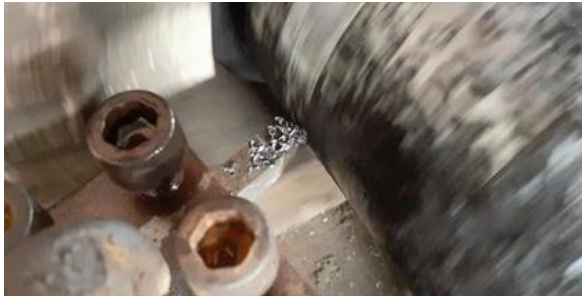
Figure 3: The process of smoothing the shaft with a lathe

Before applying the composite to the shaft, the damaged part needs to be cleaned of rust and smoothed so that the surface is flat. The smoothing process is carried out by peeling off the existing rust and roughness using a lathe. This process is carried out by rotating the shaft on a lathe and levelling it using a lathe chisel, as shown in Figure 3.

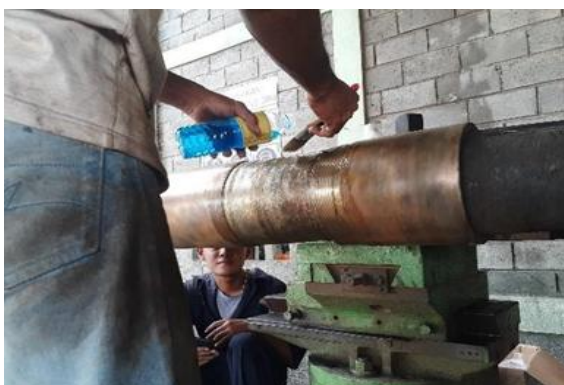
Figure 4: Cleaning rust and remaining paint

After smoothing, the damaged shaft will be cleaned using solvent and degreaser as well as alcohol. The purpose of this cleaning is to remove the remaining rust and paint that is still attached to the part. This process is shown in Figure 4.

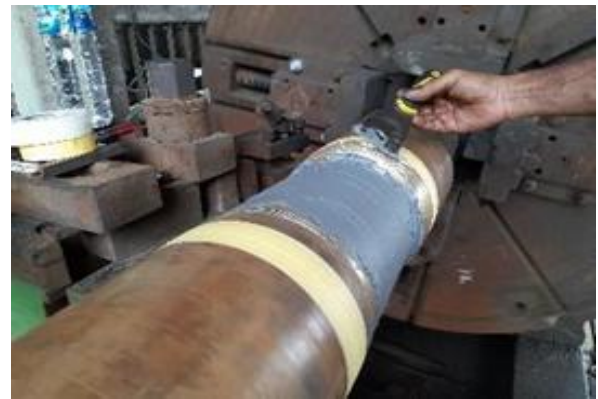
Figure 5: Application of composites to the propeller shaft

After all the dirt has been cleaned, the far right and left parts of the damaged shaft are given masking tape so that the composite does not stick to the undamaged parts. Composite application begins by mixing the base with the solidifier. The mixture is then applied to the rotating shaft and then reinforced with gauze to strengthen the composite structure as shown in Figure 5. The next process is the drying process of the coating on the shaft. During the drying process, the shaft must always be in rotation so that the applied layer does not experience creep. The shaft was rotated at a speed of 13 rpm for 4 hours.

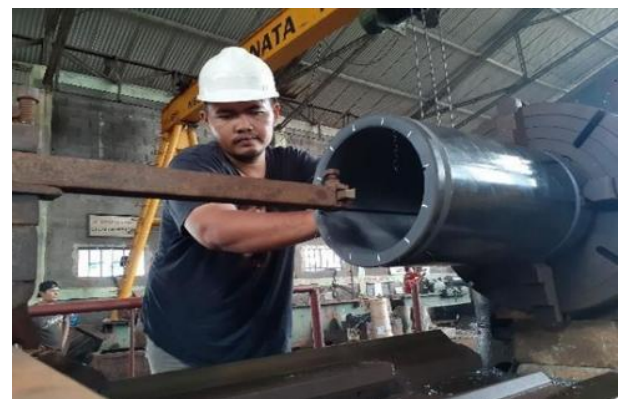
Figure 6: Bearing adjustment using a lathe

Apart from damage to the shaft, there is also damage to the bearing due to friction that occurs between the shaft and the bearing. Bearing erosion is also a factor in widening clearance. Unlike shafts, bearings cannot be repaired if they are damaged so new bearings must be purchased. The new bearing will then be machined to form an eccentric profile. This profile creation aims to adjust the alignment of the shaft on the ship. This process is shown in Figure 6.
