# Failure Analysis of a Connecting Rod Bolt in a Heavy Equipment Diesel Engine

**Abstract** - Connecting rod bolts are critical fasteners in heavy equipment diesel engines, where their structural integrity is paramount for operational reliability. This study investigates the root cause of a connecting rod bolt fracture in a heavy equipment diesel engine which have 936 Horsepower, which precipitated a catastrophic engine breakdown involving low power, overheating, and oil leakage. The failure analysis employed visual observation, macrographic examination, and Vickers micro-hardness testing to evaluate the fracture morphology and material properties. Hardness testing results revealed a core hardness of 347 HV, confirming that the bolt material (AISI 8640) retained a proper tempered martensite structure consistent with standard specifications, thereby ruling out material deficiency or thermal degradation. Macrographic analysis identified a progressive failure sequence involving two distinct mechanisms. The primary bolt failed via High Cycle Fatigue (HCF), evidenced by a flat fracture surface and ratchet marks at the periphery, indicative of reversed bending forces. The fracture of th

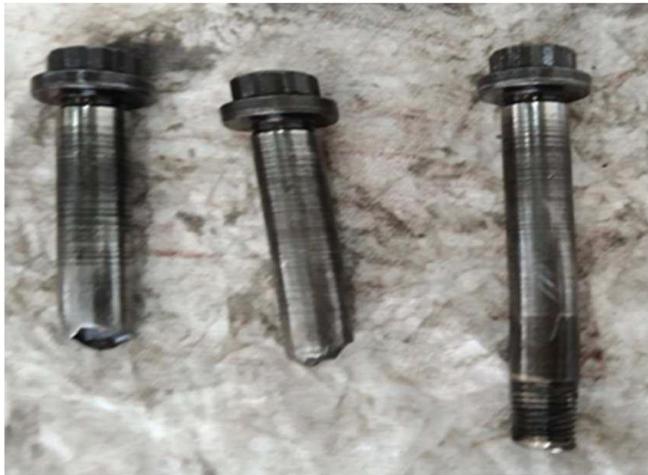
Figure 1: Connecting Rod Bolt Condition

Upon disassembly, the investigation identified the fracture of the connecting rod bolt as the primary root cause of the assembly failure. As shown in Figure 1, the severance of

Visual observation of the bolt components, as presented in Figure 1, revealed distinct traces of physical contact on the shank surface. Specifically, polished areas and circumferential rubbing marks were identified along the unthreaded section. Regarding structural integrity, two specimens suffered complete fracture characterized by flat fracture surfaces oriented perpendicular to the bolt axis, with no significant necking observed. In contrast, the third specimen remained intact but exhibited extreme plastic deformation, manifesting as severe bending deviation from its longitudinal axis.

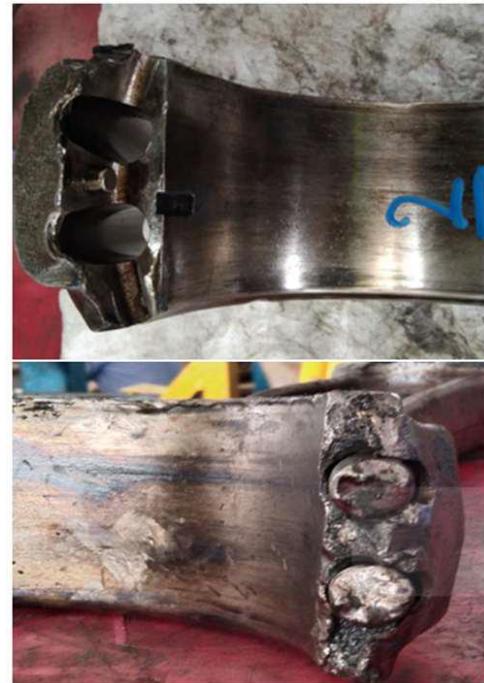
the bolt led to the catastrophic detachment of the connecting rod cap. This separation resulted in a loss of structural integrity, which subsequently inflicted severe collateral damage on the connecting rod and the cap itself, as illustrated in Figure 2.

Figure 2: Connecting Rod Cap Condition

Complementary inspection was performed on the connecting rod cap (Figure 3) to identify damage at the contact interface. The cap exhibited surface irregularities and massive plastic deformation, identified as a "hammering effect" caused by repetitive impact between the cap and the rod. Structural failure in such contexts is often dominated by fatigue mechanisms initiating from stress concentration zones or inherent material defects [12]. Furthermore, this condition may be exacerbated by excessive tightening torque and fretting fatigue induced by relative micro-motion between the cap and bearing [13].

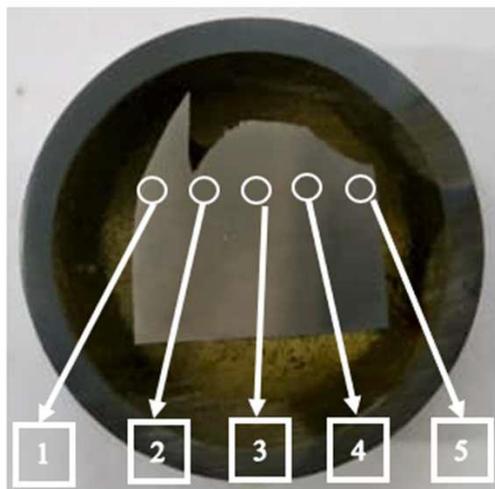
Figure 3: Vickers Micro Hardness Testing Area

To investigate the material's response to thermal and mechanical history, micro-Vickers hardness testing was performed on the transverse section of the bolt. Figure 3 illustrates the indentation trajectory. The resulting hardness values, recorded at five discrete points traversing the specimen diameter, are presented in Table 1.

As presented in the data table 1, the Vickers hardness distribution demonstrates a consistent profile ranging from a maximum of 390 HV at the periphery to a minimum of 347 HV at the core. The higher surface hardness indicates residual compressive stresses or skin deformation, which is typical for rolled threads. Analysis of this hardness profile demonstrates a stable material condition with no evidence of severe thermal degradation (overheating), which would typically result in a drastic drop in hardness. The core hardness of 347 HV (equivalent to 368 HK) serves as the most representative indicator of the bulk material's state. This value is fully consistent with the mechanical requirements for AISI 8640, a standard high-strength steel used in heavy-duty components.

The alignment of these results with the expected properties of Quenched and Tempered steel verifies the presence of a tempered martensite structure. Therefore, it can be concluded that the bolt material possesses adequate toughness and strength specifications as cited in recent studies (Triani et al., 2019), suggesting that the failure was likely driven by external loading factors rather than material deficiency.

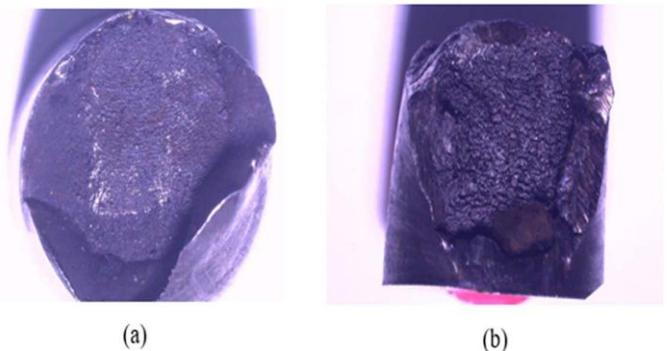
Figure 4: Macrography Photo Results of Connecting Rod Bolt Fractures, (a) Bolt 1, (b) Bolt 2

The fracture surface topography reveals two distinct failure mechanisms occurring sequentially. Specimen (a) exhibits a flat fracture surface with no significant plastic deformation (necking) and a dominant smooth propagation zone. These features confirm that failure was driven by a High Cycle Fatigue (HCF) mechanism. Notably, the presence of ratchet marks at the fracture periphery indicates multiple crack initiation origins, a condition typically triggered by reversed bending loads due to joint instability. The extensive area of the propagation zone relative to the final fracture zone suggests the bolt operated under low nominal stress but high vibration cycles, gradually reducing the effective cross-sectional area. As noted in experimental studies on high-strength bolts, fatigue cracks frequently initiate at stress concentration zones such as threads, where multi-axial loading can accelerate propagation and reduce fatigue life [15].

In contrast, Specimen (b) displays a strikingly different morphology, characterized by a rough, fibrous texture and the formation of shear lips slanted at 45 degrees along the edges. These features are hallmarks of ductile overload, where failure occurs via micro void coalescence. This phenomenon validates the material's chemical composition specifically its Nickel content which imparts high toughness, allowing significant plastic deformation prior to rupture. The distinct fracture mode indicates that this second specimen did not fail due to fatigue, but rather due to a sudden load transfer following the failure of the first bolt.

Consequently, these macrographic findings reconstruct a progressive failure chronology. The sequence initiated with joint loosening, which introduced bending forces and fatigue propagation in the first bolt. The fracture of this bolt resulted in a partial loss of clamping force, forcing the remaining bolts to bear operational loads far exceeding their yield limits. This overload caused the surviving bolts, such as Specimen (b), to fail instantaneously through ductile rupture or extreme bending deformation.
