Root Cause Analysis of Jacket Cable of Aerobridge

Abstract - Large moving facilities at airports, such as aerobridges, utilize a specific cable management system known as a cable chain, which houses power cables used to deliver electricity to the motors. These cables consist of multiple cores encased in a protective PVC jacket. However, after a relatively short period of operation, field observations revealed that the cable jackets had torn in many units. In most cases, the damage exposed the internal cable cores.

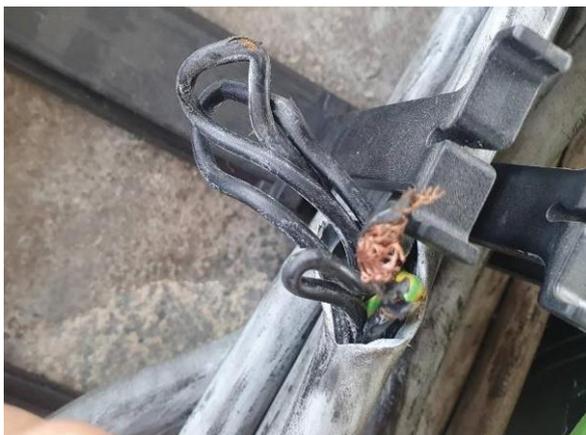
Several problems have been identified in cable chain systems, including twisted cables, damaged or injured cable jackets, broken or stretched cables, and even torn or broken chain links [3]. As illustrated in Figure 3, one common failure involves damage to the cable jacket, resulting in exposed internal cores—an undesirable and potentially hazardous condition. One significant issue is the twisting of the cable while housed inside the chain, which contributes to mechanical stress and eventual failure. This phenomenon presents an important subject for deeper technical investigation to understand its underlying causes and to develop effective engineering solutions.

Figure 3: The power cable was damaged

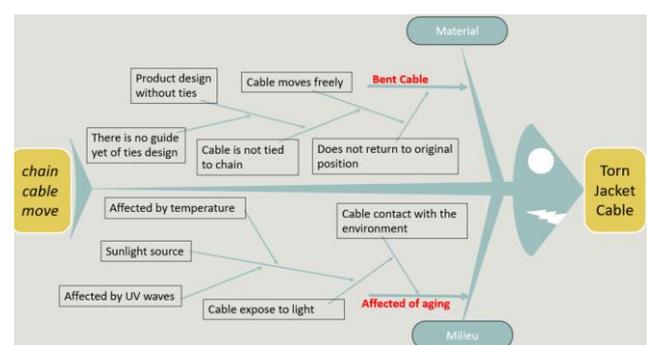
Figure 5

Focusing initially on the material aspect, a key indicator of failure was the occurrence of bent cables. Through the application of the Five Whys method and cause-and-effect analysis, it was determined that the bending resulted from the cable’s inability to return to its original position after movement. This issue was traced to the cable’s unrestricted movement within the cable chain. Further examination revealed that the cable was not secured to the chain—a direct consequence of a design that lacked provisions for cable ties. Additionally, no design guidelines or standards for cable tie implementation had been established at the time. Based on this root cause analysis, a fishbone diagram [10, 11] was developed to visualize the contributing factors, as shown in Figure 5.
