Damage Analysis of Caterpillar C9 Acert Machine Using Root Cause Analysis Method at PT. XYZ

¹⁻⁶Department of Mechanical Engineering, Faculty of Engineering, Diponegoro University, Semarang, Indonesia

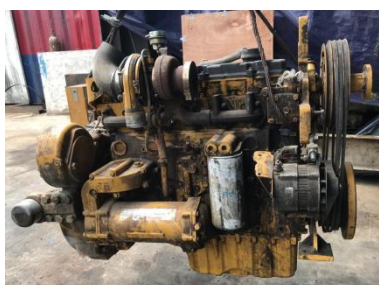
Figure 1: Caterpillar C9 Acert engine before the maintenance process

The Caterpillar C9 Acert engine is a machine produced by the company Caterpillar Inc. distributed by PT. Main Trakindo. PT. Trakindo Utama is an authorized dealer of heavy equipment for Caterpillar products, a leading manufacturer of heavy equipment in the world from America, covering the mining, oil and gas, construction, forestry and agriculture industries, as well as power systems [13]. Figure 1 shows the Caterpillar C9 Acert engine when it arrives at the workshop where the machine will be carried out for maintenance, the condition of the machine is damaged and cannot be started and it can also be seen that the machine looks dirty and looks like it has not been maintained for a long time.

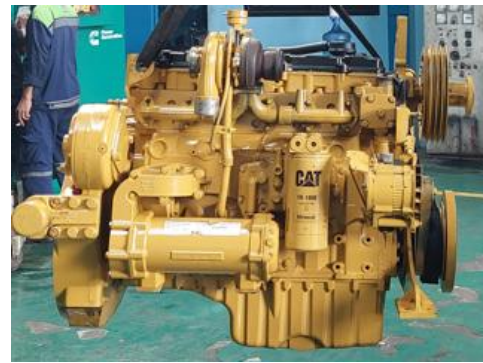
Figure 2: Caterpillar C9 Acert engine after maintenance process

Whereas Figure 2 shows the Caterpillar C9 Acert engine which has completed the maintenance process on its components, and is working as it should. It can be seen in the picture that the machine has been cleaned and repainted using an air brush with a special paint color for Caterpillar machines, namely Caterpillar yellow. Figure 2 was taken just before the machine was packed to be sent back to the client.

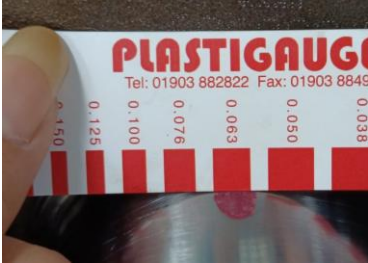
| Main Bearing | Measurement Figures | Density (mm) | Status (tolerance 0.050mm – 0.076mm) |
|---|--|---|---|
| Main bearing 1 | <p>Figure 12: Measurement of main bearings 1</p> | 0.063 | Still within tolerance |

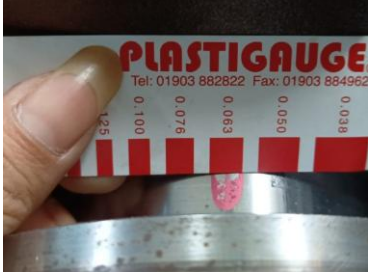
| Main Bearing | Measurement Figures | Density (mm) | Status (tolerance 0.050mm – 0.076mm) |
|---|--|---|---|
| Main bearing 2 | <p>Figure 13: Measurement of main bearings 2</p> | 0.063 | Still within tolerance |

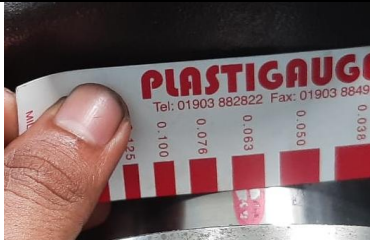
| <p>Main bearing 3</p> | <p>Figure 14: Measurement of main bearings 3</p> | <p>0.063</p> | <p>Still within tolerance</p> |

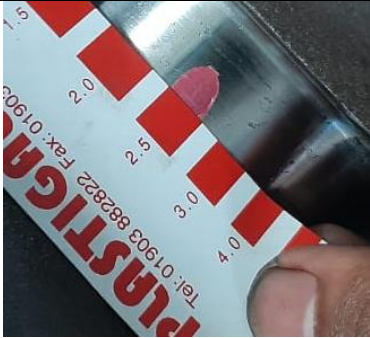
| <p>Main bearing 5</p> | <p>Figure 16: Measurement of main bearings 5</p> | <p>0.063(2.5 Inch)</p> | <p>Still within tolerance</p> |

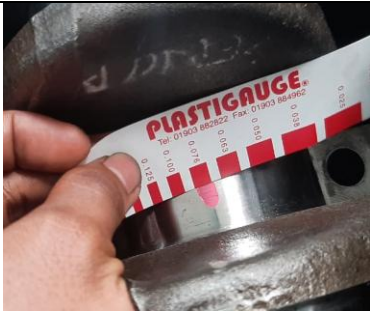
| <p>Main bearing 6</p> | <p>Figure 17: Measurement of main bearings 6</p> | <p>0.076</p> | <p>Still within tolerance</p> |

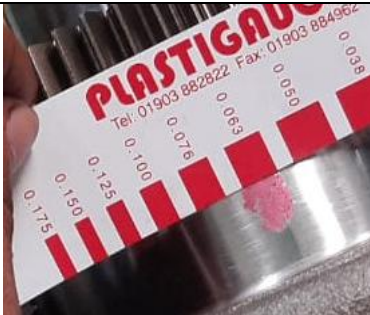
| <p>Main bearing 7</p> | <p>Figure 18: Measurement of main bearings 7</p> | <p>0.063</p> | <p>Still within tolerance</p> |

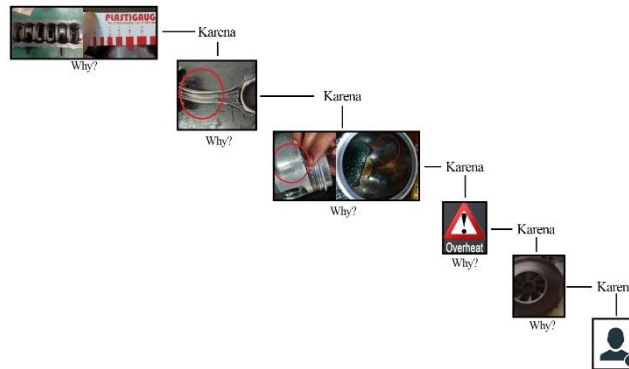
Figure 19: 5 whys diagram [16]

In this study, an analysis was carried out using the 5 whys analysis method to draw common threads and connect the damage that occurred to the Caterpillar C9 Acert engine based on the physical damage table above. In Figure 19 you can see a 5 whys analysis diagram which links the damage and its Figures sequentially, the order of the damage is then discussed in Table 4. The 5 whys analysis starts with questions followed by answers until the root cause is found. From the diagnostics that have been carried out, it was found that there were several engine parts that were damaged. Damage can be found in several engine parts such as the crankshaft, connecting rod, piston, cylinder liner and water pump.

| Why | Answer |
|--|--|
| 1st why Why can the crankshaft be damaged? | Because the connecting rod was damaged in the form of buckling which caused density measurements to be carried out on the crankshaft and main bearing to ensure that the density between the crankshaft and main bearing was still within tolerance, the crankshaft was still centered and there was no fatal damage. |
| 2nd why Why can the connecting rod experience buckling? | Because there is damage to the piston and piston ring, namely the occurrence of jamming of the piston and piston ring in the cylinder liner, this event is commonly referred to as jamming or piston jam. |
| 3rd why Why do pistons and piston rings experience jamming? | Due to overheating of the system which causes thermal expansion of the piston and piston rings, the result is that the piston and piston rings rub against the cylinder liner and leave friction marks in the form of scratches. |
| 4th why Why can overheating occur in the engine? | Because the water pump is damaged, the engine cooling system cannot work properly. |
| 5th why Why can the water pump be damaged? | Due to human error in the form of making inappropriate policies or decisions on the part of the company regarding the replacement of parts that have expired, in this case the water pump. We can know this from looking at the physical condition of the components in the water pump which look like they haven't been maintained for a long time. |
| Root cause | Inappropriate decision making by the company regarding maintenance policies. |

| Why | Answer |
|--|--|
| Corrective action | A component will not break down without cause if good maintenance is carried out on the component. If the company carries out maintenance procedures according to the manufacturer's recommendations, this damage will not occur. Of course, the company understands this risk and continues to exercise its right to establish maintenance policies that are not in accordance with standard operating procedures. The concept of risk is a very complex and rich concept, with different approaches and nuances, the concept of risk is key in all scientific, economic and productive sectors [37]. The company in the future must be even wiser in making decisions regarding the maintenance of a component in an engine by considering the existing risks. |
