Failure Investigation of Motorcycle Connecting Rod

Abstract - Connecting rod is an important component, where the connecting rod is used as a link between the piston and the crankshaft to transmit the force from the piston to the crankshaft. In this research, the connecting rod is buckling so that several tests would be carried out to analyze the mechanism and causes of the failure. The tests carried out were visual observation, chemical composition testing, metallographic testing, hardness testing and FEM simulations. The results of visual observations showed that the failure of the connecting rod was buckling at the bottom of the small end. The chemical composition test shows that the material used is AISI 4130 steel which is a low alloy steel. The microstructure that is formed is the ferrite and pearlite phases on the failed part and martensite on the part far from the failed part, because the oil in the engine runs out so there is no lubricant and coolant so that the temperature rises and causes the connecting rod decrease in hardness value, the hardness test results show if the material has an average hardness of 500 HV on the part far from failure and 350 HV on the part that

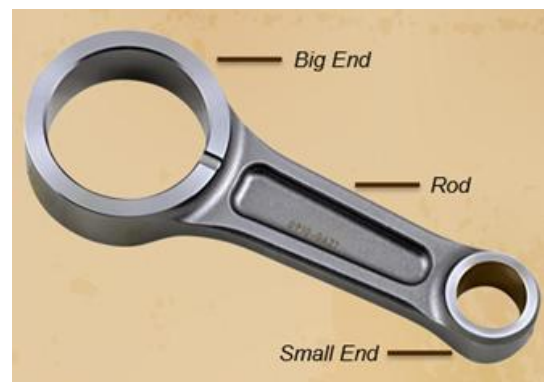
One of the most crucial parts of internal combustion engines is the connecting rod. The big end, rod, and little end make up the connecting rod. Piston movement is transferred to the crankshaft by means of the connecting rod[2].

Figure 1: Connecting Rod

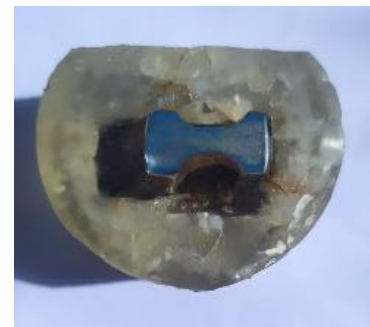
Figure 5: Specimens that have been mounted.
