Analysis of Troubleshooting Effect on the Performance of Gas Engine G-102 B (TBG620 V16K) in Central Processing Area of PT. XYZ

Abstract - PT. XYZ is a part of the largest oil and Gas Company in Indonesia, responsible for managing and developing oil and gas production activities in the East Java. The Central Processing Area serves as the facility for processing fluids produced from the East Java fields. The processed output consists of three phases: Gas, Oil, and Water. The operation of the Gas Engine G102-B TBG620 V16K running 24 hours a day to generate electricity at the central processing area of PT. XYZ requires regular maintenance, including scheduled preventive maintenance and unplanned or corrective maintenance. In the event of troubleshooting, such as a decrease in temperature in chamber 2B or a temperature sensor reading of 280 °C in that chamber, immediate corrective maintenance is necessary. Based on observations conducted in the power plant area, two possibilities causing the temperature decrease in that chamber were identified. The first possibility was the need for spark plug replacement, and the second was a malfunctioning temperature sensor resulting in incorrect r

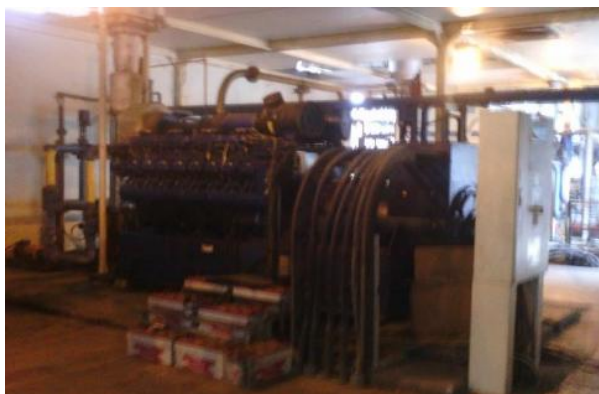
Figure 2.1: Gas Engine G102-B TBG620 V16K PT.XYZ

The Gas Engine G102-B TBG620 V16K has been running for 99,147.57 hours or approximately 11 years. With proper and regular preventive maintenance, the performance of this gas engine can be maintained to ensure it continues to generate maximum power output in order to sustain the production process in the Central Processing Area (CPA).

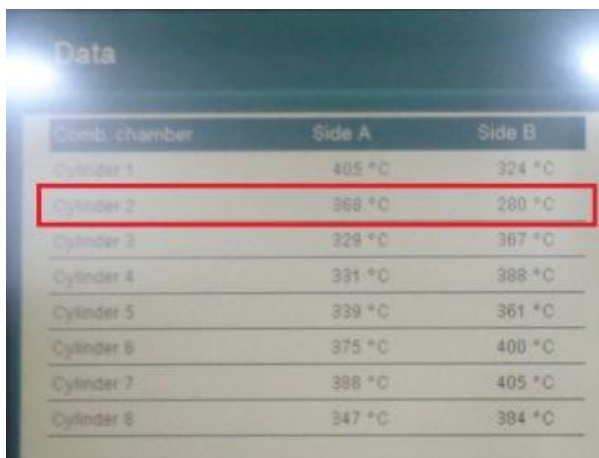
Figure 2.2: Temperature reading on the Gas Engine Chamber by the PLC

After performing preventive maintenance of 1000 hours, which involved oil replacement, oil filter replacement, and cleaning, a problem was discovered regarding a decrease in chamber temperature. Normally, the temperature is above 300°C, but it dropped to 280°C in Chamber 2B. If this problem is not promptly addressed and the temperature continues to decrease to 250°C, it can cause the engine to experience knocking and eventually lead to engine breakdown, resulting in a complete stoppage of operation.

Following up on the issue, based on the troubleshooting section in the manual book and the table below, there are two possibilities: either the spark plug is nearing the end of its lifetime[6] causing a decrease in temperature in Chamber 2B, or the temperature sensor in that chamber is damaged, resulting in inaccurate temperature readings.

After conducting observation and troubleshooting analysis, it was decided to perform corrective maintenance by replacing the spark plug as shown in Figure 3.1 in the Chamber 2B section. After the replacement, which took approximately 60 minutes, the engine resumed normal operation. However, the indicator on the PLC monitor panel still showed a temperature of 280°C, as shown in Figure 3.2 above.
